Manhole Inspection Summary

Manhole # S55C__029MH

Insp Date: **6/20/08 1:35 PM**

Location Address: **rear 3537 e fairmount ave**

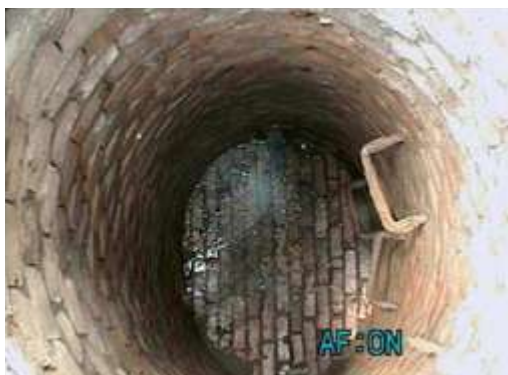
Defect 4

Count: **4** Missing: **1** ☒ **Corroded**

corroded steps

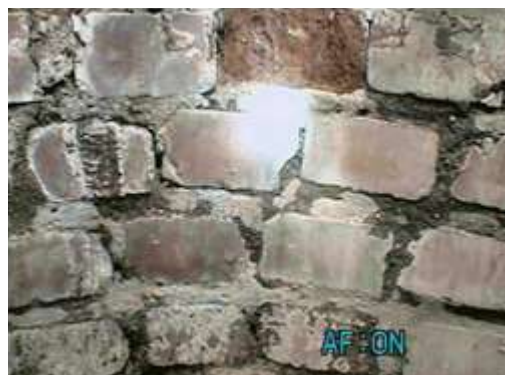
Defect 3

Condition: ☐ Sound ☐ Cracked ☐ Root Intrusion ☐ Loose Brick ☒ **Deteriorated**

missing brick in corbel

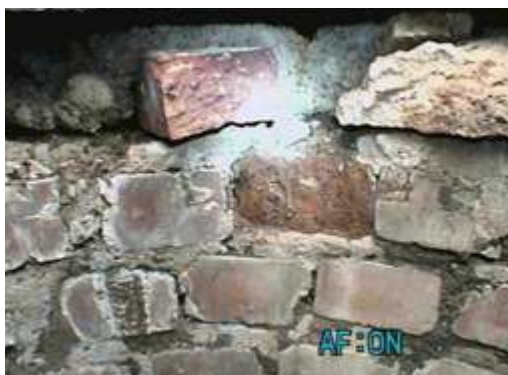
Defect 2

Condition: ☐ Sound ☐ Cracked ☐ Root Intrusion ☒ **Loose Brick** ☒ **Deteriorated**

chimney loose bricks,deteriorated,
frame adj

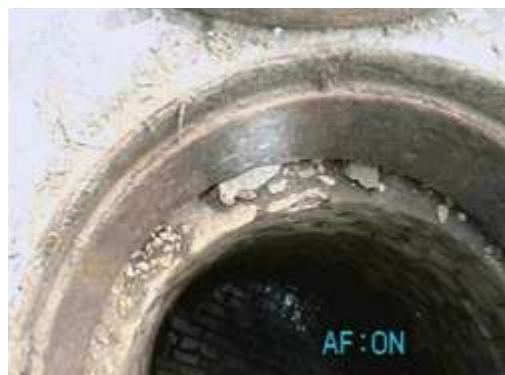
Defect 1

Offset: **2** (in.)

offset

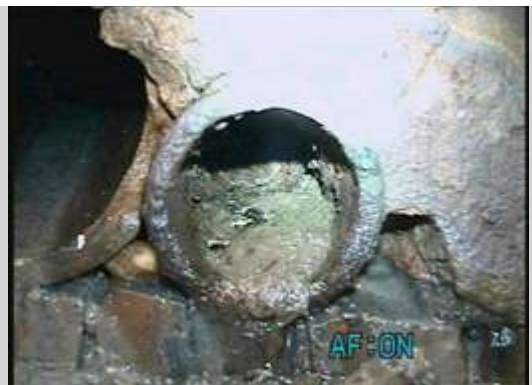
9 O'Clock Inflow

Deposits: ☐ None ☐ Mud ☒ Sludge ☐ Debris ☐ Grease

Silt Depth: 2 (in.) Deposits Extent: Medium
